Archaeometallurgical and Comparative Study of Material Characterization and Qualities of Two Profiles of Historical Argentine Railways of Different Gauges and Their Fixing Elements

Abstract

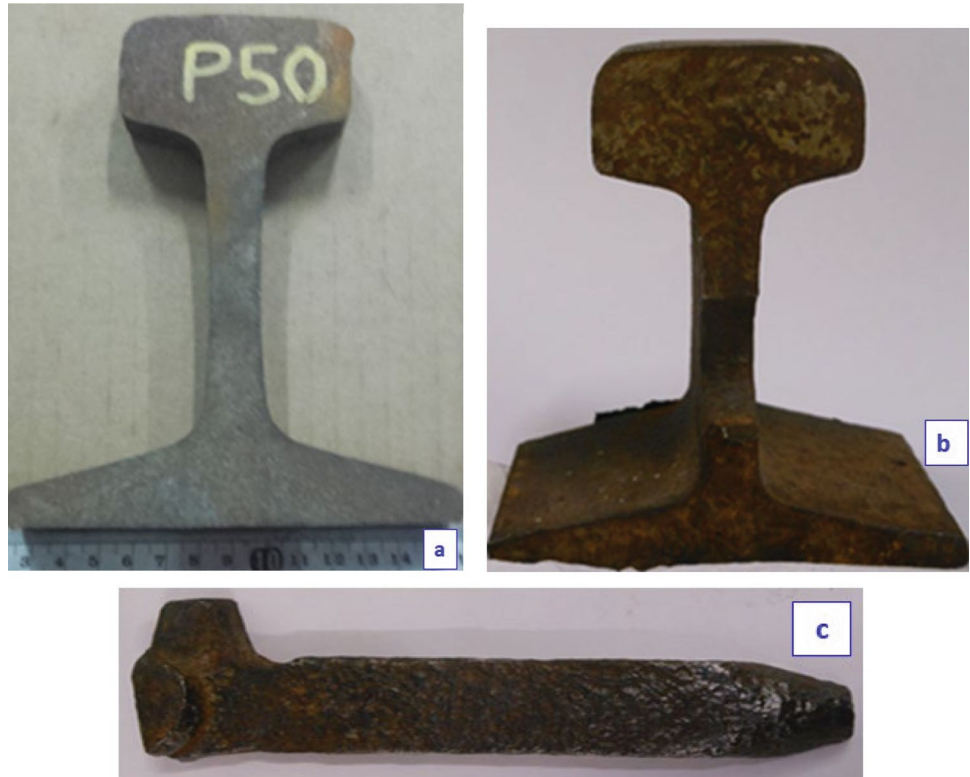
Fig. 1 (a) P50 rail wide gauge 1520 mm of Sovietic origin; (b) 750 mm narrow gauge rail of German origin; (c) fixation nail of Belgian origin

The study focuses on two Vignole type railway rail profiles: one rail is a wide gauge P50 (1520 mm, Soviet origin), and the other rail is a narrow gauge (750 mm, German origin) and a fixing element (Belgian origin). This study intends to analyze the characteristics of the materials used in the Argentine historical railways through micrographic and macrographic analysis, chemical composition, hardness measurement and make a comparison with the materials used in current railway rails. The pieces investigated are part of the railways of the provinces of Mendoza and Chubut (both in Argentina). The rails of the railway lines in a large part of Argentina are around 100 years old, so the corresponding historical revisionism is also carried out (Fig. 1).

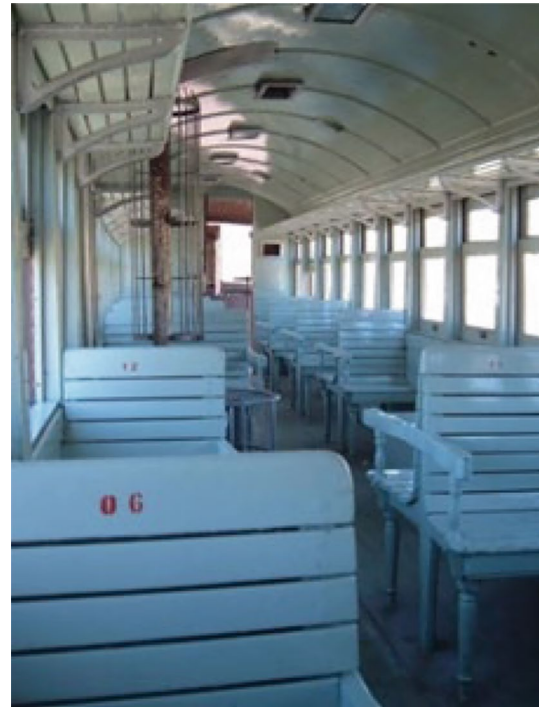
Fig. 4 (a) Map route of the line between Esquel (yellow circle) and Buenos Aires (green circle); (b) Map route of the line between Eng. Jacobacci (blue circle and Green line) and Esquel city (blue circle and

red line) of the Old Patagonian Express, in Chubut province (Patagonia, Argentina)

However, until 1950 it was just a freight train. The first passenger service launched in 1950 connected the city of Esquel (blue circle with red point) with the capital city of Eng. Jacobacci (blue circle with white point). The passengers traveled on hard wooden benches (Fig. 5), in the case of second class cars, and all the passenger cars had a stove (salamander type), which was used to cook, and also to prepare the Mate (typical Argentine hot infusion) and primarily for heating purposes. The passenger train journey that linked Patagonia with the national capital Buenos Aires was approximately 16 h.

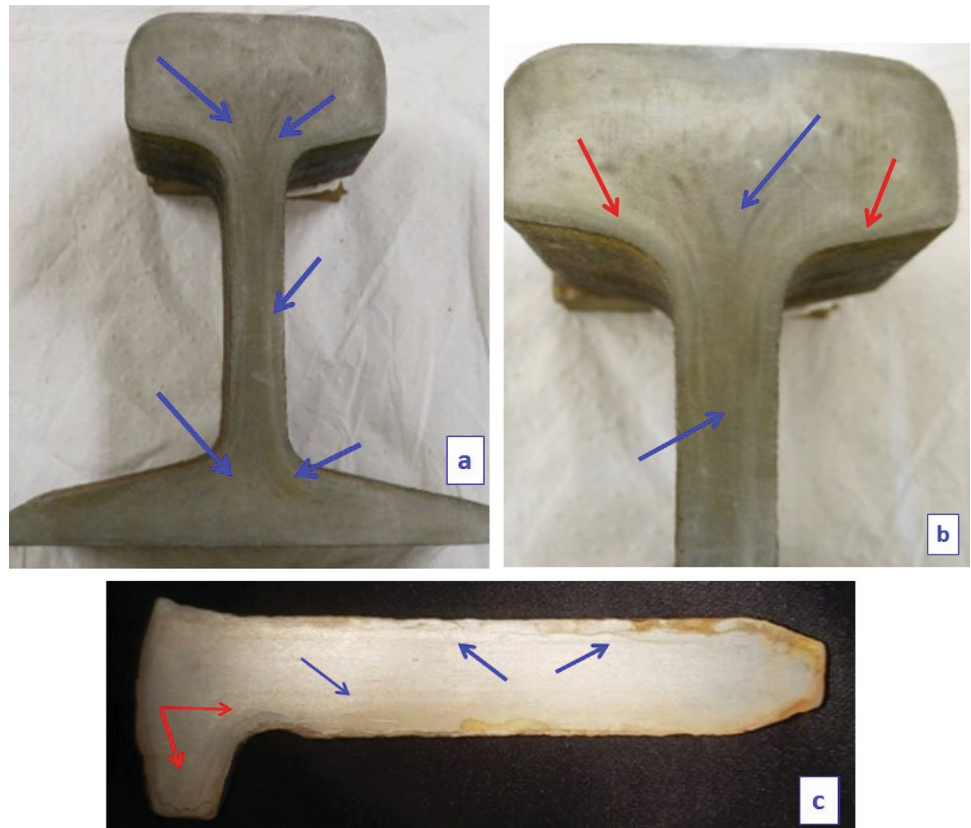
Fig. 12 (a) and (b) Macrographs of the narrow gauge rail (750 mm) and (c) the fixing nail, both pieces belong to the Old Patagonian Express “La Trochita” Museum

In the macrostructures, both the used rail profile and the fixing nail were sectioned longitudinally, the surfaces were prepared by conventional sanding and polished, and then both surfaces were pickled with 2% Nital reagent for 2–4 h. using a container for this purpose.

Figure 12a, b and c reveals clear and homogeneous structures, the flow lines (blue arrows) of the laminate are perfectly visualized from the head, passing through the web of the rail and going to the foot, and there are no cavities, drains or spiracles. The red arrows on the head of the narrow gauge rail point to the contour flow lines. In particular, it is observed that the dendritic structures have been conveniently eliminated, so that no cracks or fissures are observed. Generally, a minimum reduction ratio of 4 to 1, i.e.: 4 inches in the cast form to 1 inch in the rolled or forged form, is required to break the dendritic structure.

It should be noted that in the steel there are slight segregation regions that follow the contours of deformation in the production of the product, indicated with blue arrows in the central area of the narrow gauge rail and the fixation nail. These areas represent areas of higher concentration of some

Narrow Gauge rail macrographs reveal clear, homogeneous structures and in particular, no cracks or fissures are observed. It should be noted that in the narrow gauge rail steel there are slight regions of segregation that follow the deformation contours in the production of the product. These areas represent areas of higher concentration of some chemical elements such as: manganese (Mn), phosphorus (P), silicon (Si), sulfur (S).

In the macrograph of the fixation nail, it is possible to observe the flow lines along the piece and the flow lines specifically in the area of the head of the fixation nail following its contour. These rolling flow lines along with the hardness values are indicators of how the part was manufactured. In the case of the fixation nail, an increase in hardness values is observed from the head of the nail towards its tip. The fixing nail, being a fastening piece, behaves elastically, so the manganese (Mn) present gives it greater ductility and therefore an elastic behavior, that is, the material is capable of supporting loads, flexing, without breaking and then when
